# Allied-Axis

THE PHOTO JOURNAL OF THE SECOND WORLD WAR

# Contents

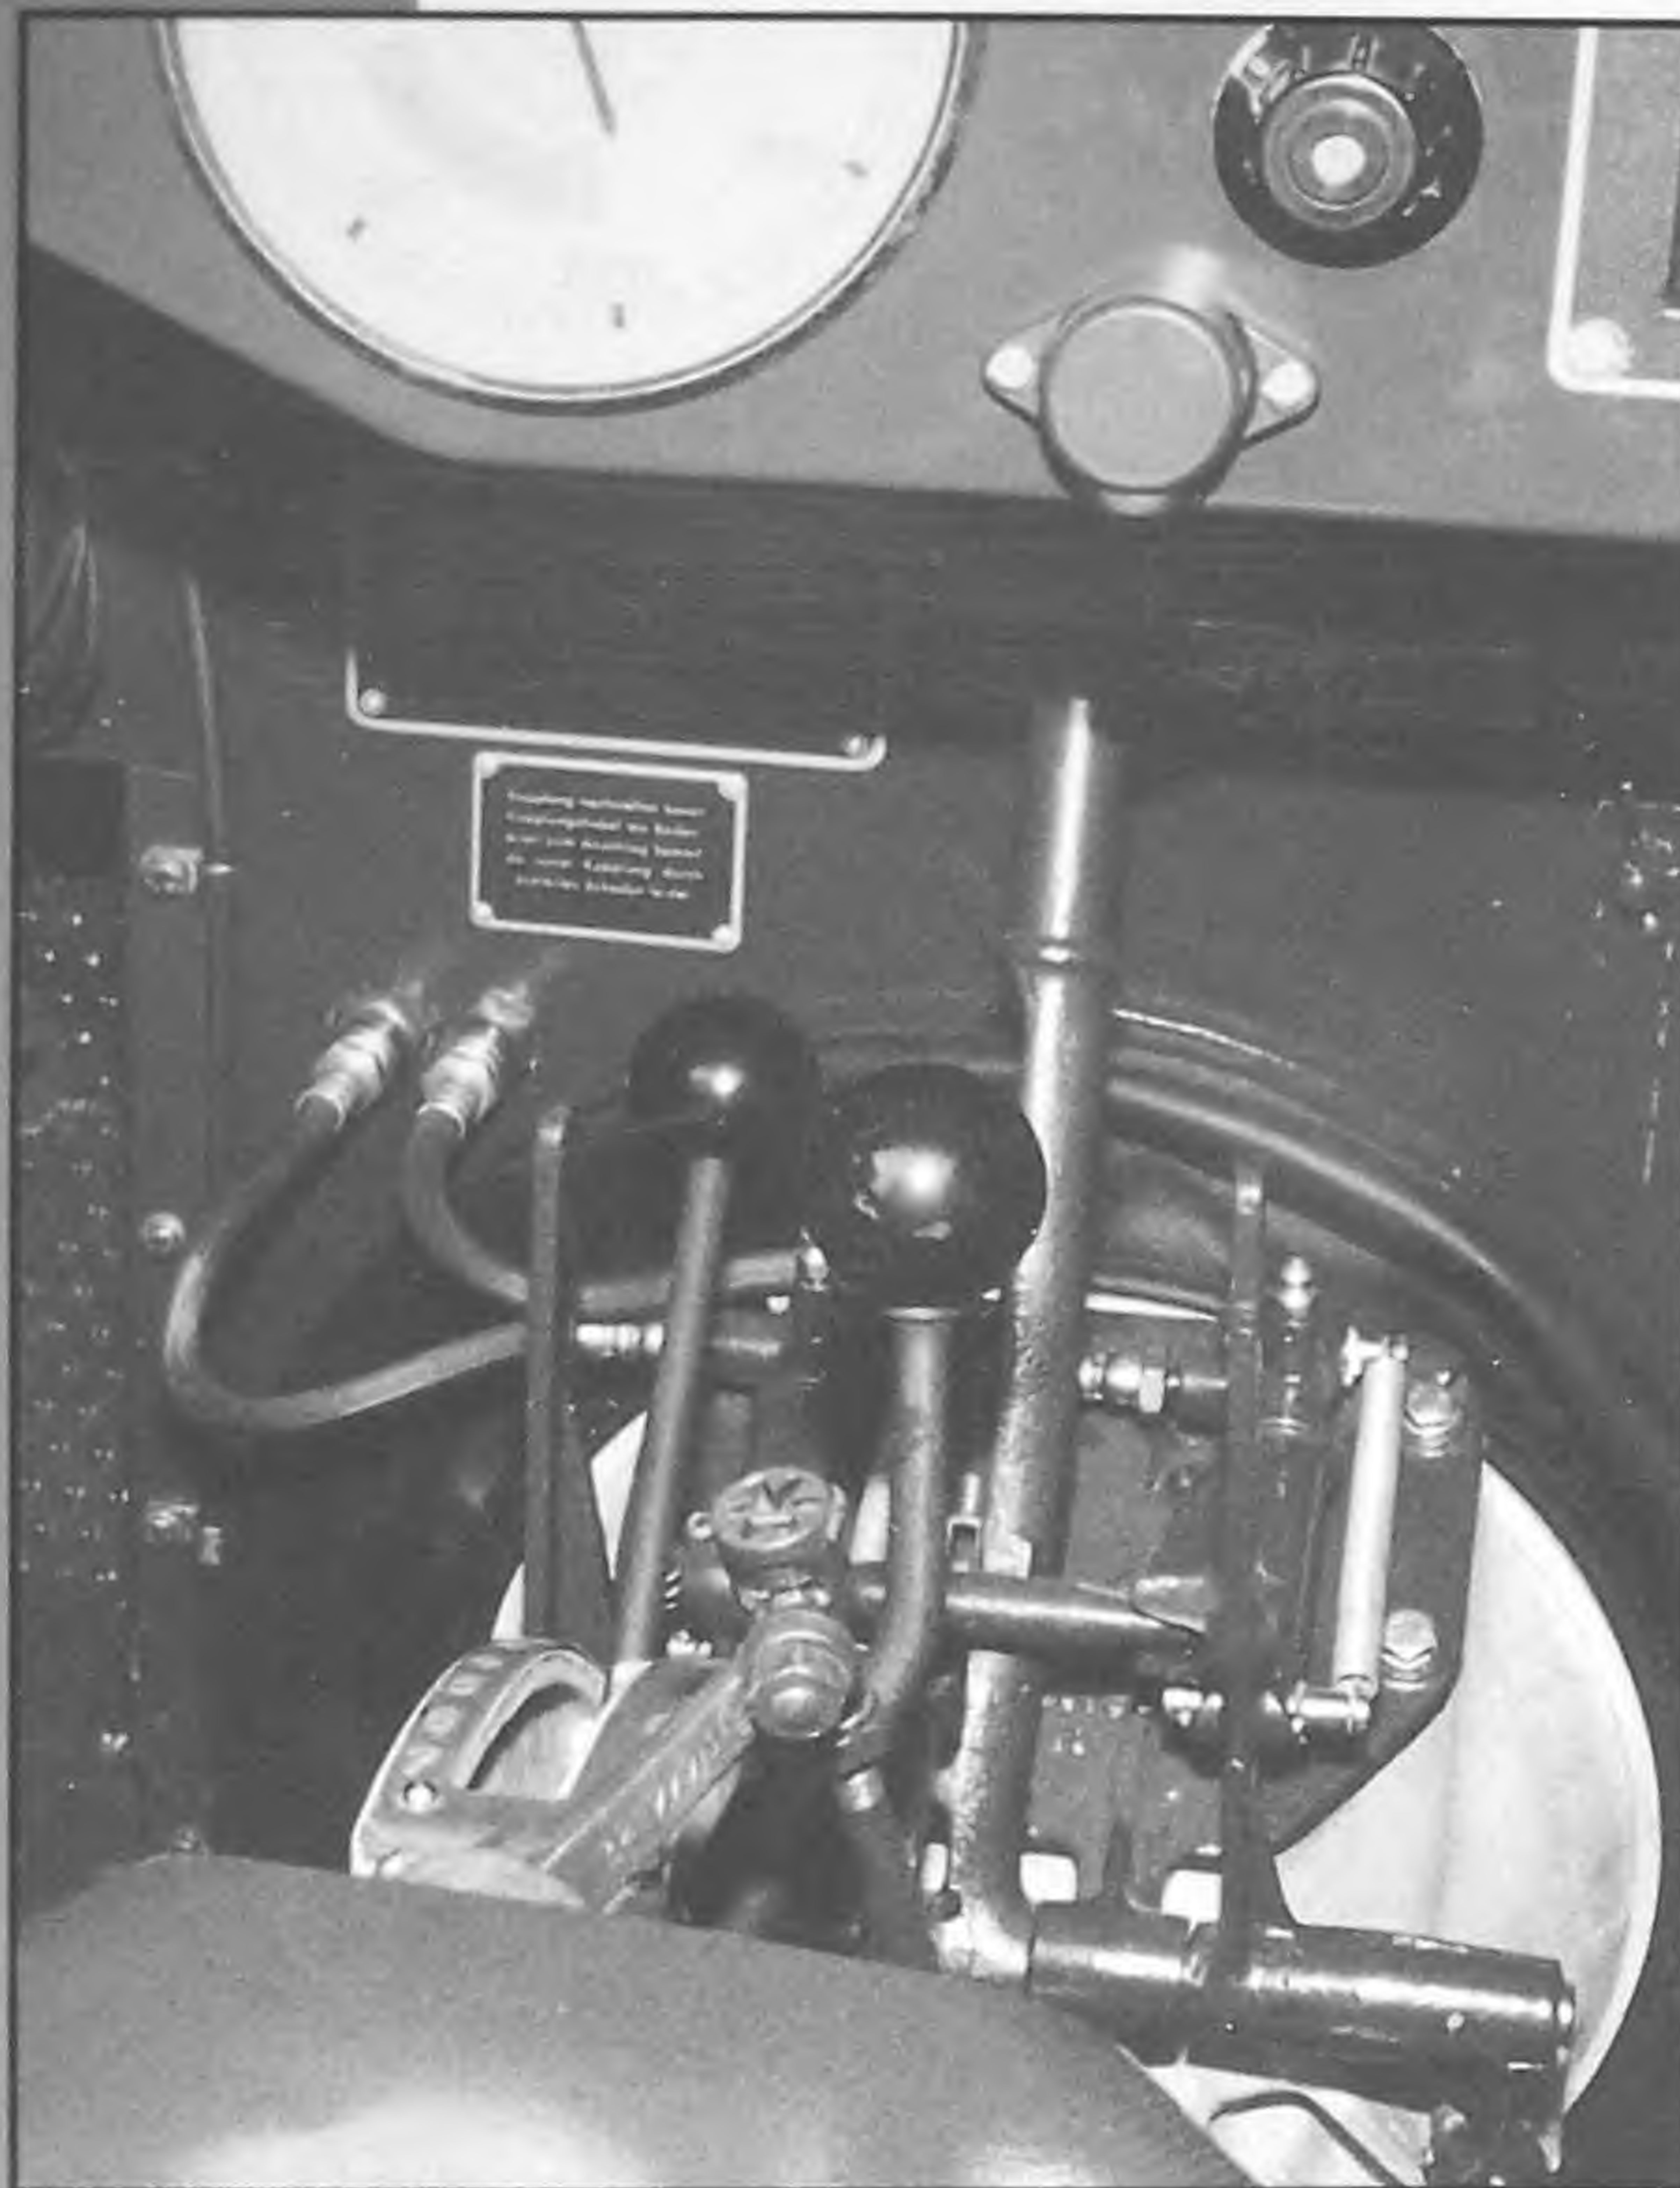
**Above:** a closer look at the transmission and its controls. The transmission had seven forward speeds and three reverse. The number of gears made the tachometer an essential part of the driving operation! **Top right:** The forward MG shield and mount. This forward mount is unique in that it cradles both the center and the stock of the gun, making it an extremely stable platform for firing, even when the vehicle was moving. **Right:** the locker at the rear of the vehicle could hold twelve cans of MG ammunition, each of which contained five 50-round belts. These belts could be easily linked together for continuous fire.
